SAFETY ALERT BULLETIN

ACCIDENT REDUCTION PROGRAM

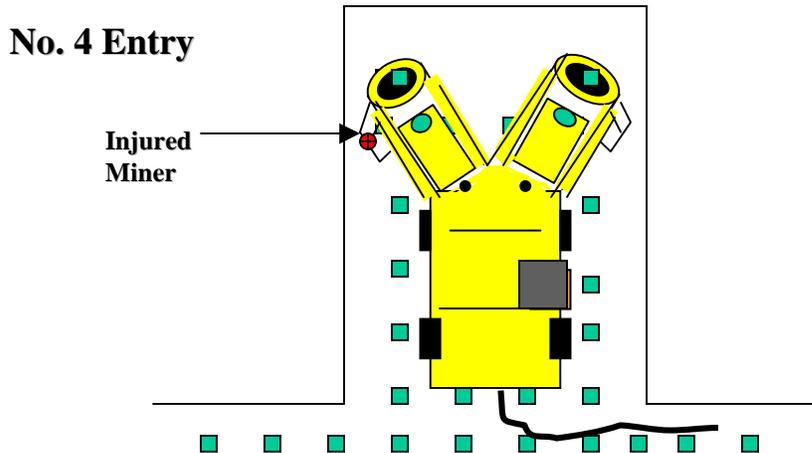
On Friday morning, April 30, 2004, at 12:30 A.M., a roof bolter operator was seriously injured while he was installing roof bolts with a dual boom Lee-Noris roof bolter. The control block fast feed was stuck in on the left side of the drill and blocked in on the right side, causing the roof drill operation to function at a higher rate of speed than normal. The fast feed control lever was missing and the boom control lever as well as the rotation control lever were bent toward each other allowing one handed operation. The roof bolter operator had already pushed glue and a bolt into the drill hole, when the 36" bolt wrench which was still in his left hand, caught on the drill boom as he lowered it. This pushed the wrench into his left groin area creating a 3" long by 4" deep laceration, causing considerable blood loss and pelvic injuries.

- Never operate equipment faster than your skill or a safe operating speed allows.
- Any safety or operational defect in equipment should be repaired immediately.
- Manufacturer's design of equipment should not be bypassed or altered changing the original function of the controls or operation of the equipment.
- Proper hydraulic pressures should be maintained on the equipment according to the manufacturer specifications.
